EndurAlloy Corrosion Applications

EndurAlloy Tubing offers a unique combination of corrosion, abrasion and erosion resistance that can reduce or eliminate tubing failures for oil and gas production.

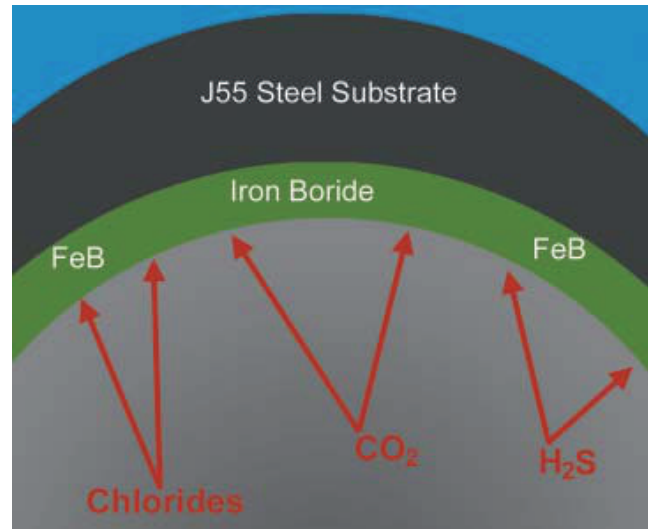
The EndurAlloy surface is comprised of one atom of boron and one atom of iron, which combine to create a molecule of iron boride. EndurAlloy provides excellent corrosion resistance because it is inert and non-reactive to most of the corrosive elements found in oil and gas production.

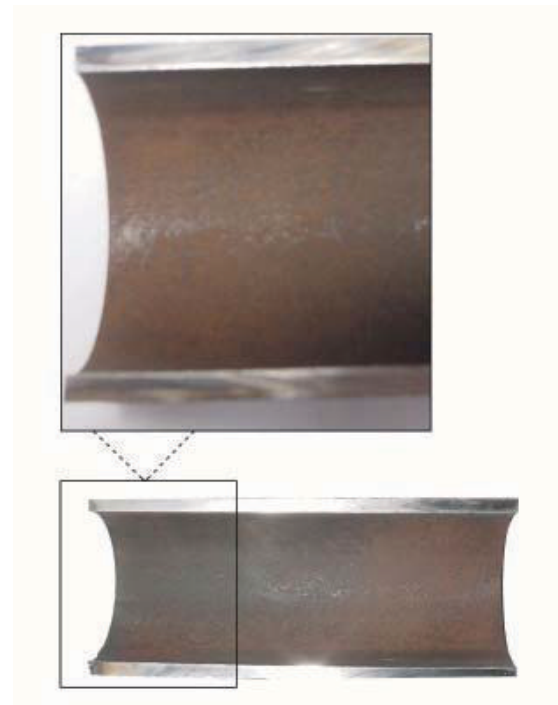
West Texas Well

The section of EndurAlloy Tubing pictured above was removed from a corrosive well (H₂S and bacteria) near Midland, Texas. The customer was getting two to three months from the joint above a rod pump. They installed one joint of EndurAlloy Tubing in April 2004. Six months later the tubing was pulled to replace the pump and the joint of EndurAlloy Tubing was removed for inspection. Even though it had already lasted three times the run-life of the bare steel tubing it replaced, the EndurAlloy joint showed no visible signs of corrosion or wear.
